INDOOR AIR QUALITY ASSESSMENT

**Priest Street School
Modular Classroom Building
115 Priest Street
Leominster, Massachusetts**

Prepared by:
Massachusetts Department of Public Health
Center for Environmental Health
Bureau of Environmental Health Assessment
Emergency Response/Indoor Air Quality Program
October 2004

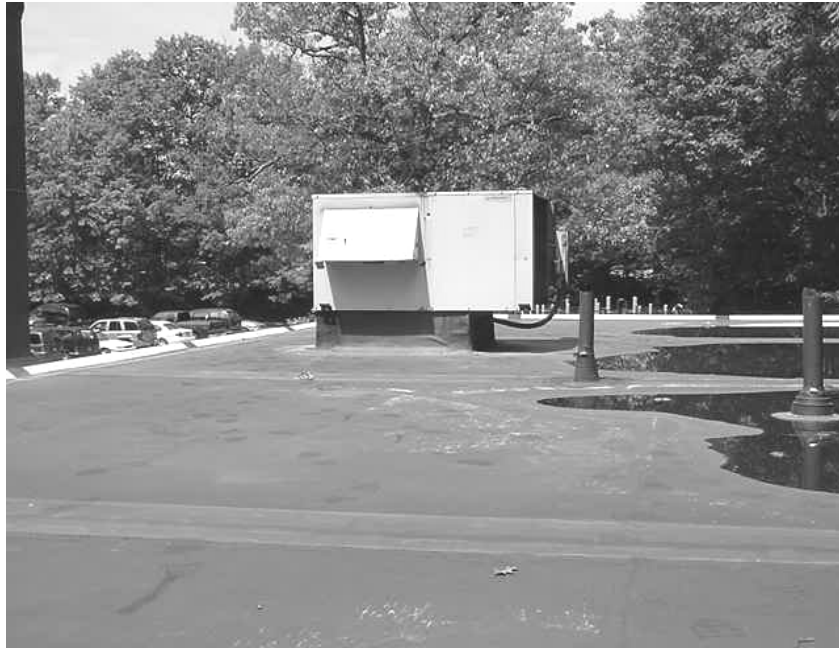
Picture 1

Ventilation in the modular classrooms is provided by two rooftop air handling units (AHUs) (Picture 1), which were deactivated at the time of the assessment. A thermostat controls the heating, ventilating and air conditioning (HVAC) system. Thermostats have settings of “on” and “automatic”. Thermostats were set to the “automatic” setting. The automatic setting on the thermostat activates the HVAC system at a preset temperature. Once a preset temperature is measured by the thermostat, the HVAC system is deactivated. Therefore no mechanical ventilation is provided until the thermostat re-activates the system.

Rooftop AHU

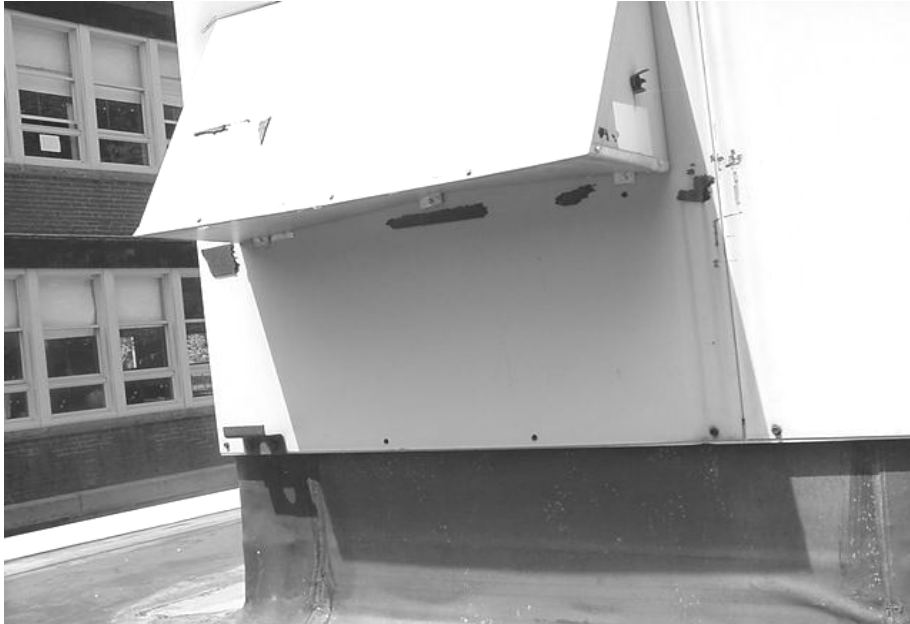
Picture 2

The fresh air intakes for the AHUs were sealed with sheet metal (Picture 2), thereby limiting the ability to provide fresh air. Since the AHUs do not have the ability to exhaust air, the operation of the AHUs would be expected to recirculate air. Modular classrooms are designed to be energy efficient; therefore, little outside air penetration occurs, except when windows are open. Under these conditions, concentrations of normally occurring environmental pollutants (e.g., heat, odors) can build up, resulting in increased comfort complaints for some individuals.

Sealed AHU Fresh Air Intake

- 1) Open fresh air intake vents in the rooftop AHUs.
- 2) Operate the ventilation system continuously during school hours.
- 3) Reconnect the restroom flexible duct.
- 4) Remove carpeting up to three feet from the threshold of exterior doors. Replace carpeting with a non-slip, nonporous material (e.g., rubber matting, tile).

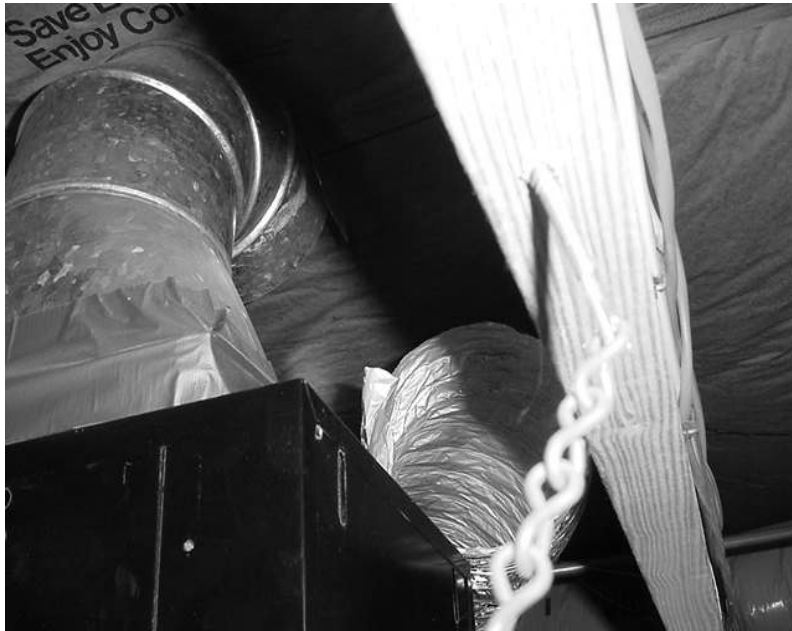
Picture 3

This increase in relative humidity can indicate inadequate exhaust ventilation or that a moisture source is penetrating into the building interior. For example, the restrooms in the modular building are vented. At the time of the assessment, the flexible duct connecting the exhaust fan to the outdoor vent was not attached properly (Picture 3). As a result, water vapor and associated odors from restrooms were venting into the ceiling cavity instead of outdoors, which may be contributing to water vapor accumulation. Additional moisture sources are discussed later in this report.

Flexible Duct Disconnected from Restroom Exhaust Fan Housing

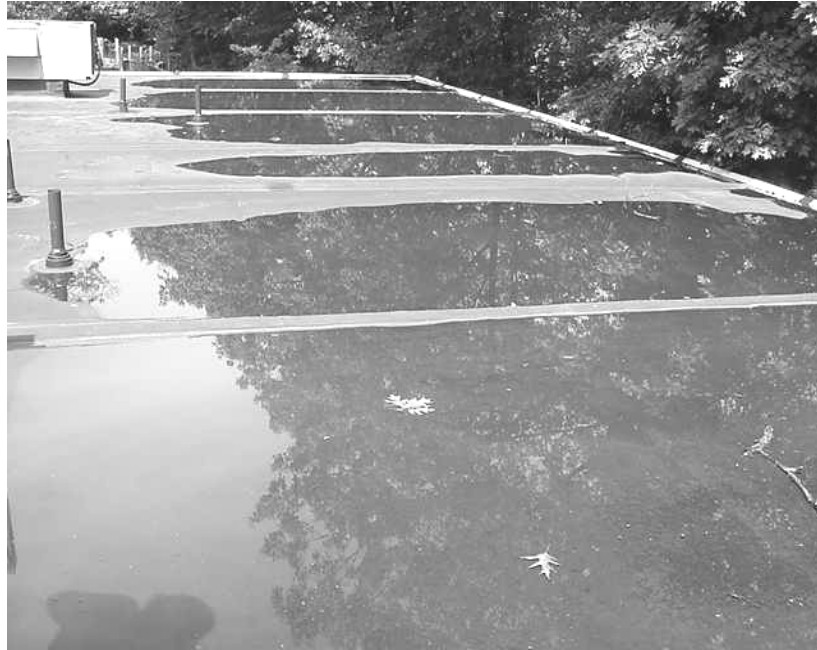
Picture 4

- The roof of the modular building does not have a means to drain, due to the rubber membrane roofing material installed over roof drains (Picture 4).
- A significant amount of plant debris is accumulated on the roof (Picture 5).
- The modular building was partially installed on pavement (Picture 6). The rear of the building is installed over soil, onto which downspouts empty. Over time, rainwater has compacted the soil, creating troughs in which water may accumulate against the exterior wall and pool beneath the modular structure.
- The soil at the rear of the modular structure is not graded to slope away from the building. Without grading the soil, rainwater cannot readily drain away from the rear of the structure.

Accumulated Water on Roof

- 6) Reestablish drainage and remove accumulated debris from roof.
- 7) Remove skirting from the base of the building to examine water pooling. Seal all holes in the underside of the modular classrooms with an appropriate sealing compound to prevent air and water vapor penetration into the modular classrooms. Once sealed, replace damaged skirting materials.

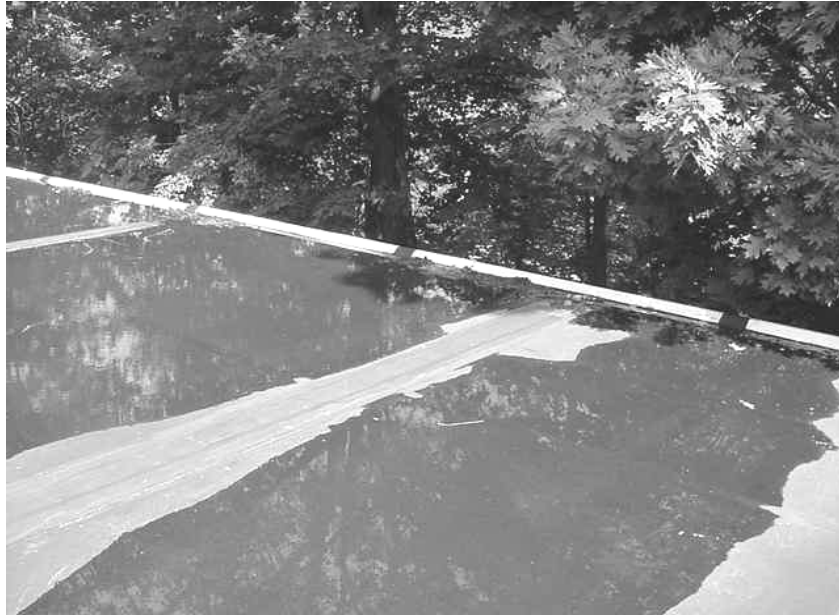
Picture 5

Accumulated Materials on Roof

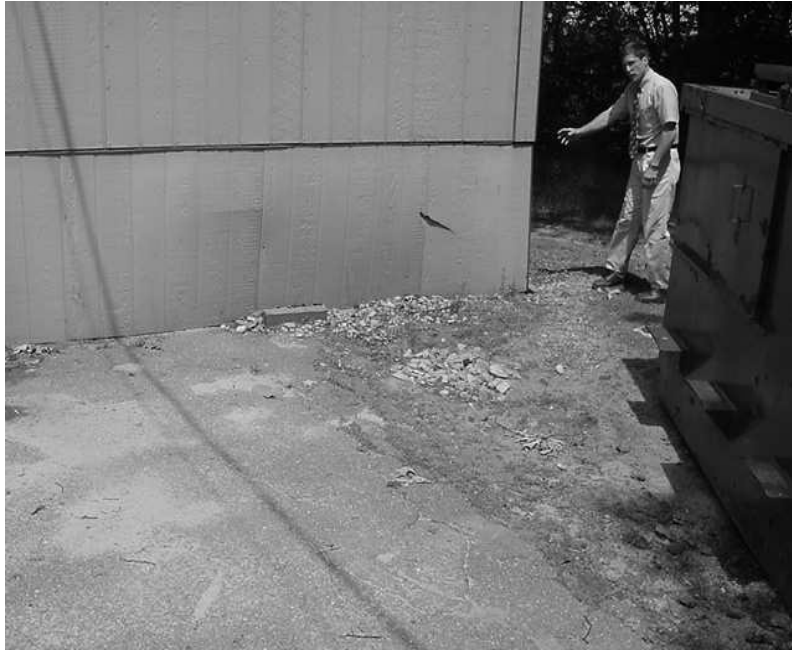
Picture 6

Modular Building Installed Partially over Soil

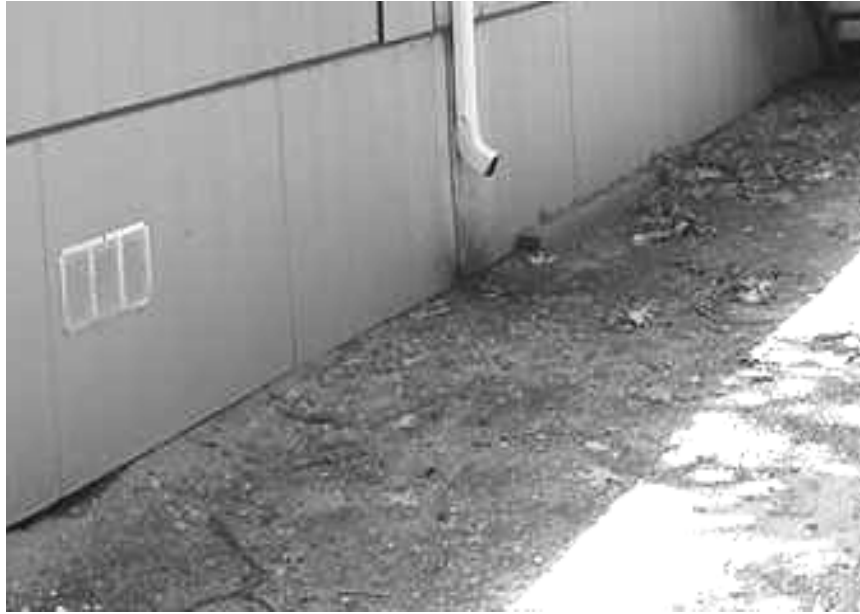
Picture 7

The accumulation of water at the base of the modular building causes chronic wetting of the exterior wall (Pictures 7 and 8). Downspouts should be designed to direct rainwater away from the base of the exterior walls to prevent rainwater from penetrating beneath the building. Wetting of exterior walls and soil beneath the building can result in mold growth.

Water Damage to Exterior Wall

- 8) Examine the feasibility of directing downspout water away from the base of the building.
 - a) Improve the grading of the ground away from the foundation at a rate of 6 inches per every 10 feet (Lstiburek & Brennan, 2001).

- b) Install a water impermeable layer on ground surface (clay cap) to prevent water saturation of ground near foundation (Lstiburek & Brennan, 2001).

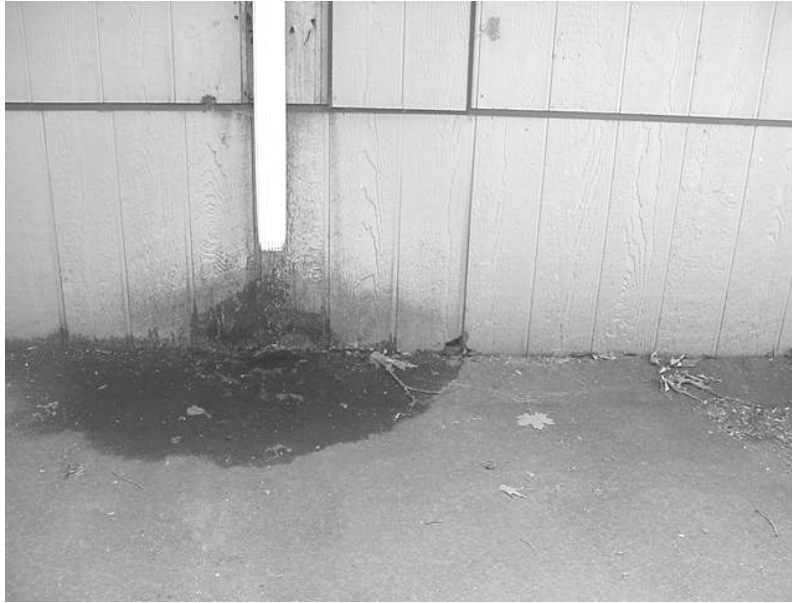
Picture 8

Water Damage to Exterior Wall

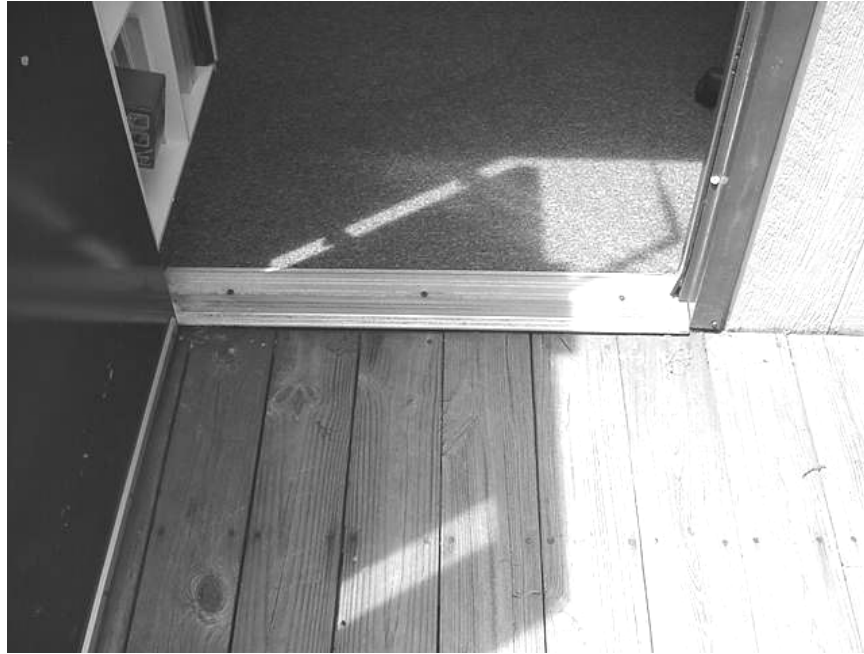
Picture 9

- The exterior door is located in the southwestern corner of the building. The prevailing winds in Massachusetts tend to be from the west. Moist weather tends to travel in a northeasterly track, up the Atlantic Coast towards New England (Trewartha, 1943). Wet weather systems generally produce south/southwesterly winds. Driving rain is most likely to strike this door during wet weather patterns.
- A wooden staircase was installed for access beneath this door (Picture 9). The level of the landing stair was installed beneath the door threshold. The door threshold does not have flashing installed to prevent water from penetrating into the doorframe when driving rain runs along the stair landing.
- The door frame threshold was not rendered watertight with the doorframe, providing a water migration pathway.

Stairwell beneath Exterior Door Threshold

- 5) Install flashing under the exterior door thresholds in order to prevent water penetration. Seal threshold seams with an appropriate sealant. Install a door sweep and bottom of each exterior door.

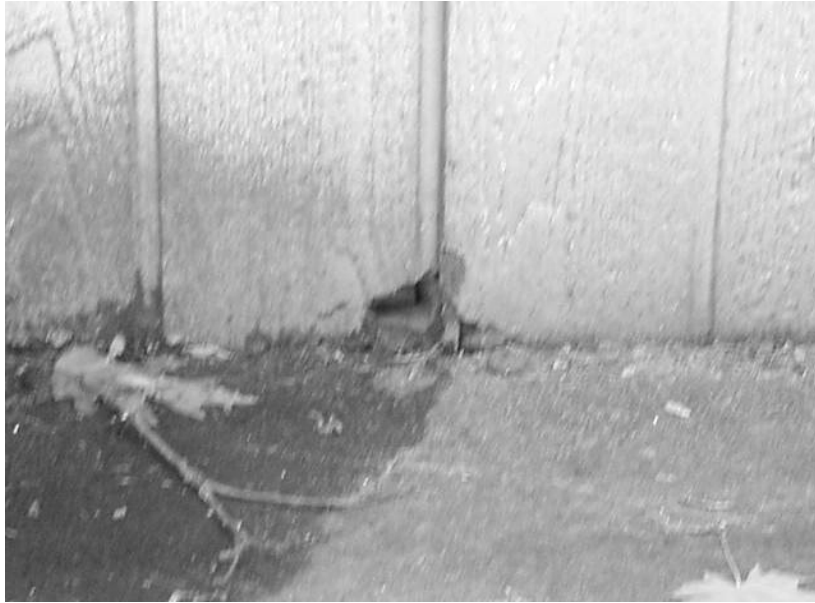
Picture 10

Several other conditions were noted during the assessment, which can affect indoor air quality. Occupants reported problems with chipmunks in modular classrooms. A chipmunk was observed entering the modular crawlspace through a hole in the exterior wall skirting (Picture 10). If chipmunks have penetrated into the building space, it is also likely that other rodents (mice) may also exist in the structure. Rodent infestation can result in indoor air quality related symptoms due to materials in their wastes. Mouse urine is known to contain a protein that is a known sensitizer (US EPA, 1992). A sensitizer is a material that can produce symptoms in exposed individuals, including running nose or skin rashes. A three-step approach is necessary to eliminate rodent infestation:

Chipmunk Entry Point into Crawlspace

- 9) Use the principles of integrated pest management (IPM) to rid this building of pest. The IPM recommendations are available at the Massachusetts Department of Food and Agriculture (MDFA) website:
http://www.state.ma.us/dfa/pesticides/publications/IPM_kit_for_bldg_mgrs.pdf.
